# Finite Element Simulation and Multifactor Failure Analysis of an Important Stepped Shaft Fracture Events<sup>1</sup>

**Abstract:** Aiming at a fracture event of an important stepped shaft parts, ABAQUS finite element method was used to simulate and analyze. The results show that the stress concentration is serious at the step where shaft fracture occurs. The maximum stress occurs at the R2 transition corner. The maximum stress value under the most unfavorable condition is 319.9MPa, which exceeds the yield strength limit of the material. Scanning Electron Microscope and X-ray Energy Spectrum analysis shows that fracture of the shaft is a fatigue fracture initiated by multiple sources. Design analysis states clearly that the initiation is mainly related to the small turning radius of the step, which causes the stress concentration factor increase. At the same time, the shoulder height is higher which cause the sudden change of the section size, and will aggravate the stress concentration effect. Furthermore, machining quality analysis indicates that the rough surface with micro-defects due to the out of control of metalworking may be the origin of fatigue crack initiation. Heat Tr

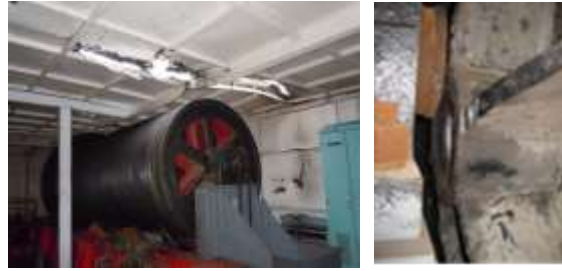
A 450t crane in a company, which has been in operation for 3 years, is used in large lifting operation. Due to the breakage of the drum shaft of the lifting mechanism, the lifting objects fall to the ground and the crane is damaged.

Fig.1 Drum Shaft of Lifting Mechanism of Crane

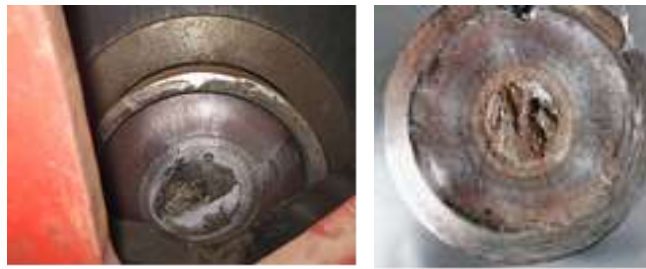
The fracture surface is located at the step of the stepped shaft. Macro morphology of the section is fatigue fracture and the final fracture zone is small (about  $\Phi 40\text{mm}$ ).

Fig.2 Macro-morphology of fracture surface

Statistical data of hoisting mechanism operation show that the actual load state exceeds the L2-intermediate level of the design standard load spectrum, and it is easy to accelerate the fatigue damage of mechanical parts. At the same time, the fatigue fracture surface accounts for about 85% of the area of the cross-section, and the potential safety hazard cannot be found in daily use.

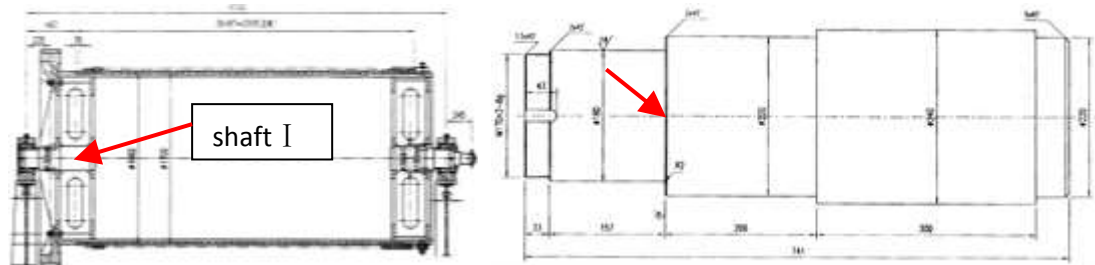
The structure of the drum and the shaft is shown in Fig.3. The fracture occurs at the turning angles of the steps of  $\Phi 180\text{mm}$  and  $\Phi 220\text{mm}$  of the shaft I, as indicated by the arrow.

Fig.3 Structural sketch of drum and shaft

The design structure diagram shows that the radius of transition corner  $R=2\text{mm}$  at the step shaft  $\phi 180\text{mm} / \phi 220\text{mm}$  is less than the national standard value, and it is quite different from the industry standard value. If the radius of transition corner is too small, the stress concentration factor will increase. The shoulder

height is higher which cause the sudden change of the section size, and will aggravate the stress concentration effect.

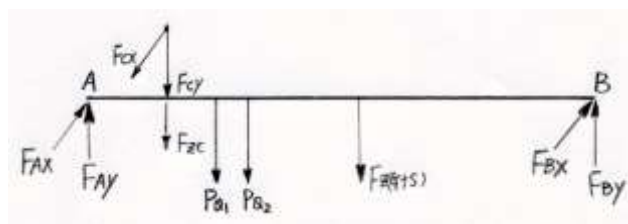
According to the working conditions, the force analysis sketch of the drum structure is drawn as shown in Fig.4, and the bearing support reaction of the drum shaft is solved. The results are shown in Table 1.

Fig.4 Diagram of force analysis of drum structure

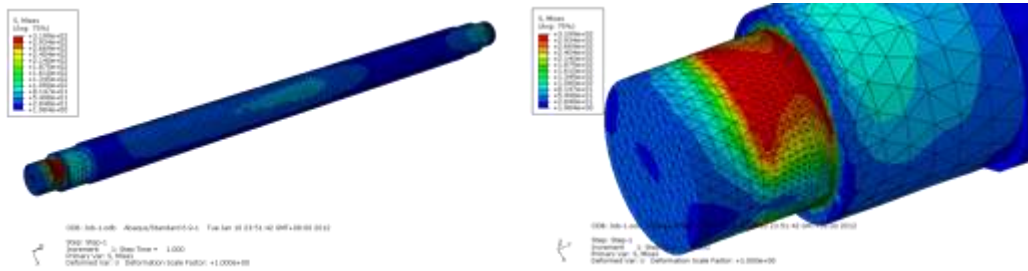
Fig. 10 Stress Distribution of the Shaft and Its Left End

From Figure 10, it can be seen that the stress concentration occurs at the fracture site of the shaft under rated load. The stress distribution phase diagram of its left end is analyzed. Maximum stress occurs at the transition point of R2 fillet. The maximum stress value is 319.9MPa, which exceeds the yield strength limit of the material  $R_{el}=315\text{Mpa}$ . In order to stereoscopically reflect the stress state of this section, the section is cut off along R2 rounded cross section, XY plane and YZ plane, and the stress distribution diagram is also shown in Figure 11.

1. According to ABAQUS finite element simulation calculation, the maximum stress of local stress concentration exceeds the yield strength limit of material under the most unfavorable conditions at the transition corner of the shaft's  $\phi 180 \text{ mm}/\phi 220 \text{ mm}$  step.

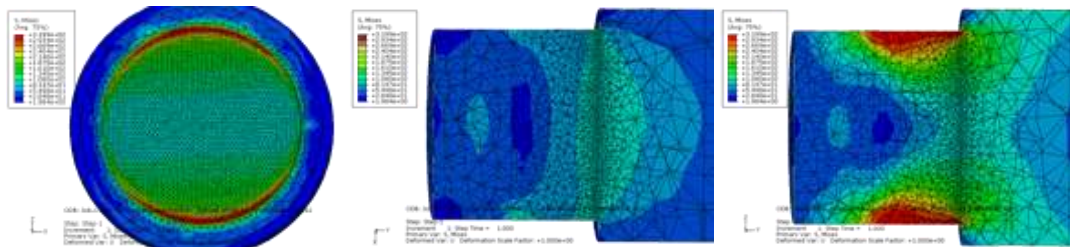
Fig. 11 Stress Distribution Diagrams of Cross Section, XY Section and YZ Section at R2 Round Corner at Axis Fracture

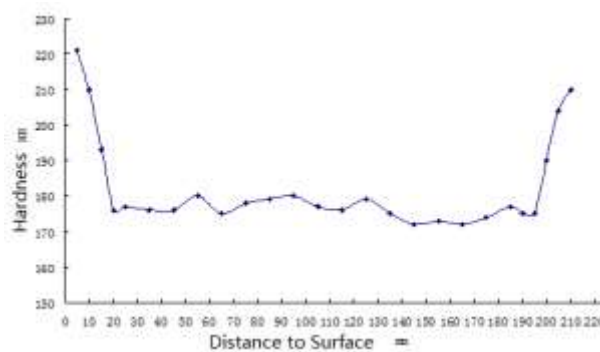
According to the technical requirements of the shaft (35 steel), the hardness after quenching and tempering should reach 170HB–200HB. Brinell hardness (Fig. 12) was measured from surface to interior on longitudinal of the shaft at  $\Phi 220\text{mm}$  fracture section. Physical and chemical test results show that the actual near surface hardness (220HB) exceeds the technical requirements, and the effective quenching layer depth is shallow, which has a certain impact on fatigue strength.

Fig. 12 Hardness gradient on longitudinal section of shaft at  $\Phi 220\text{mm}$  fracture zone

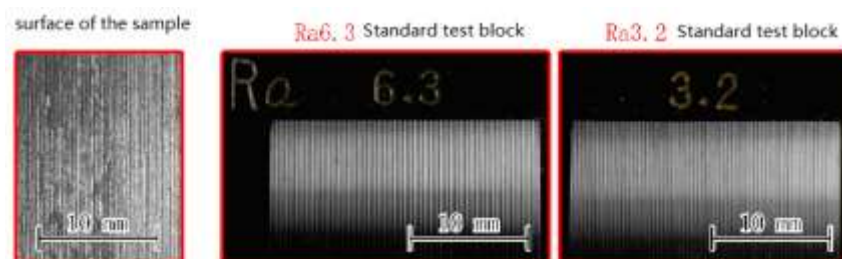
Compared with the roughness sample, the surface quality of the shaft is between  $3.2\text{ }\mu\text{m}$  and  $6.3\text{ }\mu\text{m}$ , and the roughness of the surface does not meet the design requirement of  $Ra1.6\text{ }\mu\text{m}$  (Fig. 13). Surface state coefficient  $\beta$  has some influence on fatigue fracture, and surface micro-defects may be the origin of fatigue crack initiation.

Fig. 13 Comparisons of Surface Roughness in Turning

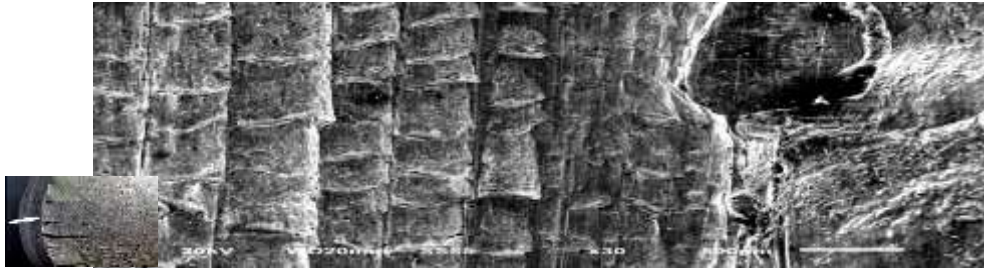
The fatigue fracture of shafting can be clearly confirmed by scanning electron microscopy (SEM) analysis of the fracture surface of shafting (Fig. 14). Parallel fatigue growth fringes and intergranular secondary cracks can be seen in the sub-edge region, showing brittle morphology.

Fig. 14 Machining Traces of Rough Surface of Axis and Sub-layer Fatigue Glow
